# DEM Quality Determines Watershed Accuracy

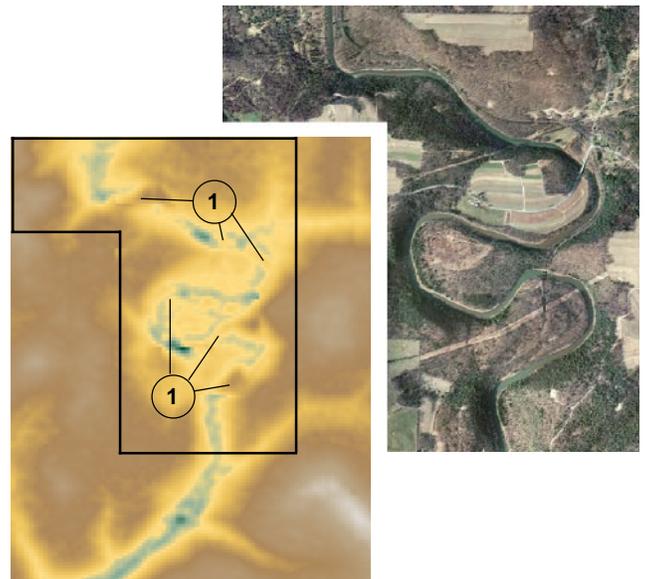
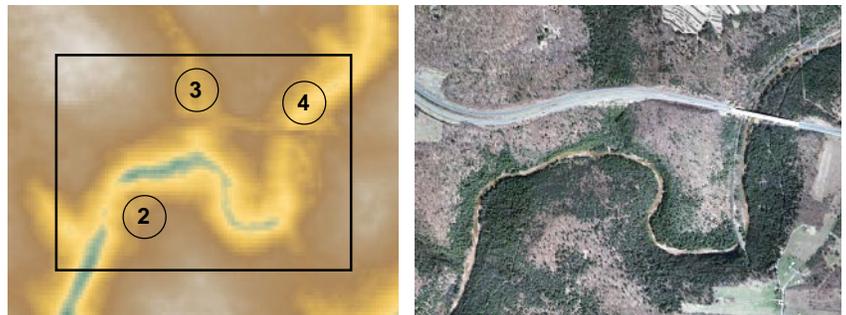
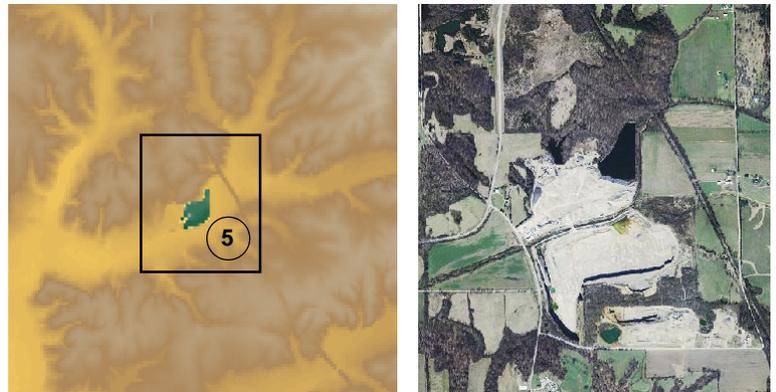
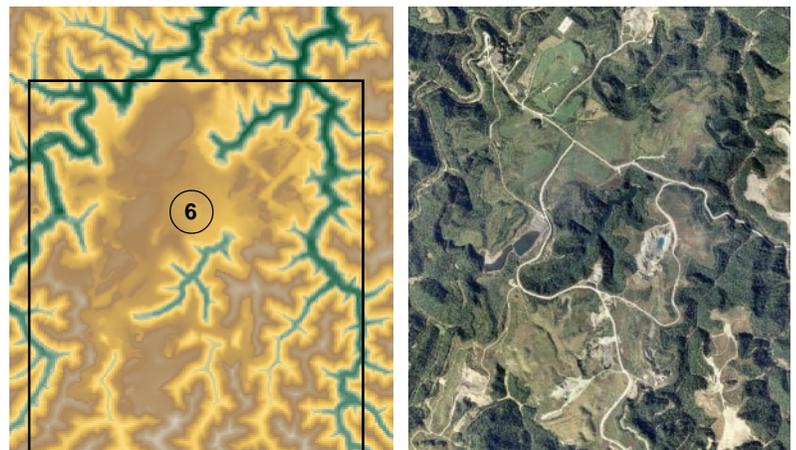
**Local Elevation Anomalies Encountered in 1 arc-second (30-meter) NED**  
(numbers keyed to illustrations)

- ① General poor data quality producing stream valley blockages; probably older data produced by photogrammetric methods.
- ② Anomalously high elevations in stream valley in area with patches of coniferous forest (dark green in leaf-off color orthophoto); data probably produced by photogrammetric methods.
- ③ Highway embankment depicted in DEM blocking stream valley.
- ④ Highway bridge depicted in DEM blocking stream valley.
- ⑤ Quarry creates local artificial depression in wide stream valley.
- ⑥ Strip-mined area with ridges removed and spoils dumped in adjacent valleys; wholesale blockage of drainages.

the United States by photogrammetric methods (manual profiling and electronic image correlation) include striping artifacts, anomalously high elevations in areas of forest cover, and patchy areas of poor elevation quality. Some of this older, poor-quality data persists locally in the current National Elevation Dataset (NED) of the United States distributed by the U.S. Geological Survey. As examples of the elevation errors that may occur, some of the production artifacts that MicroImages has encountered in the 1 arc-second (approximately 30-meter cell size) NED are tabulated and illustrated below along with color orthoimages of the problem areas.
